111-40-10070-2020 CORRECTION

Water body name: Survey date: 10/24/2013
Water body number: 111-40-10070-2020 Species & Lifestage: COr

Watershed: Mendenhall River-Frontal Gastineau Channel

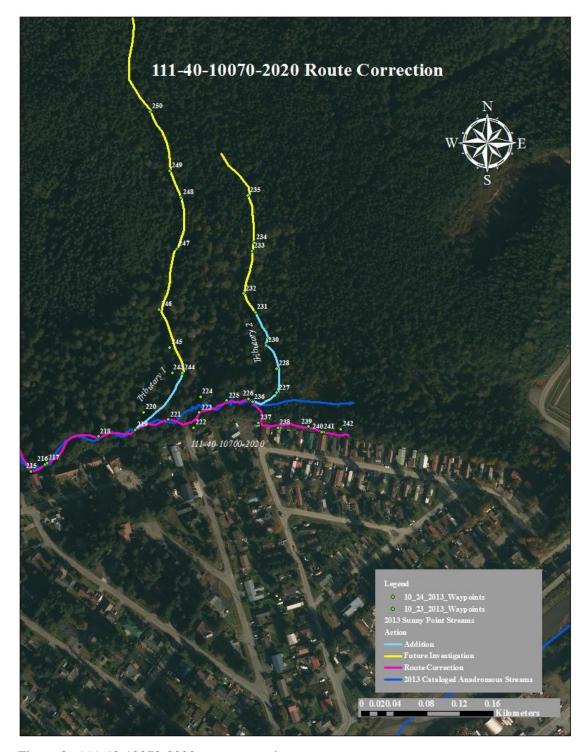
Figure 3.–111-40-10070-2020 route correction map.

Findings: I surveyed 111-40-10070-2020 using an electrofisher unit and a GPS (Table 1). I captured rearing coho salmon and Dolly Varden char (Figure 1). This stream is crossed by Switzer Loop Trail and continues up behind residential mobile homes (Figure 2). I ended the survey behind Churchill Mobile Home Park where water is seeping out of the ground.

Recommendations: Correct the current course in AWC.
